TEST REPORT

NUMBER : TWNH00011246

FOUR (4) UNITS OF SUBMITTED SAMPLES SAID TO BE :
ITEM NAME : MARINE GPS ANTENNA & RECEIVER
ITEM NO. : (A)MA700 (B)MR700
QUANTITY : 4 UNITS (2 UNITS PER ITEM NO.)
DATE SAMPLE RECEIVED : SEP 26, 2008
DATE TEST STARTED : SEP 30, 2008

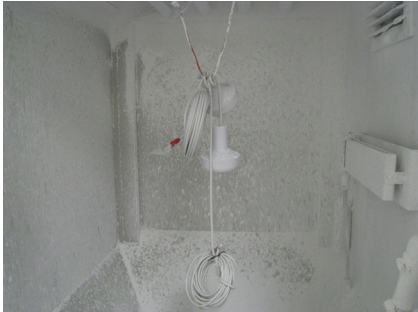
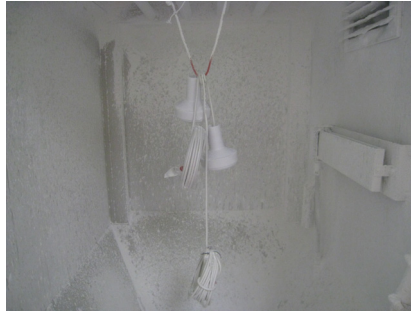
EQUIPMENT : DUST DEGREE TEST SYSTEM
MANUFACTURER : PTL
MODEL NUMBER : P14.41

- SAMPLE SIZE: 2 UNITS
- SETUP PHOTO:

- COMPOSITION TYPE : TALCUM POWDER
- PARTICLE SIZE : < 0.075 mm
- THE AMOUNT OF TALCUM POWDER: 2 KG PER CUBIC METER
- TOTAL TEST TIME : 8 HOURS

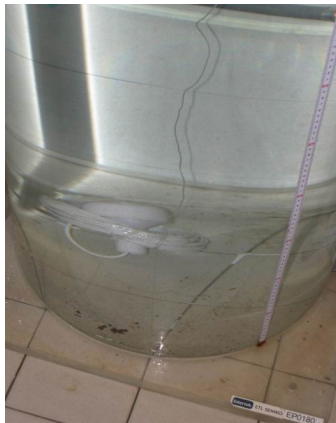
EQUIPMENT : IMMERSION TANK
TEMPERATURE OF THE WATER : 23°C
DATE OF CALIBRATION : MAR. 19, 2008

- SAMPLE SIZE: 2 UNITS
- SETUP PICTURE:

IMMERSION DEPTH : 1000 mm (BETWEEN THE SURFACE OF THE WATER AND SAMPLE'S BOTTOM)
